## Water and Sanitation in the News

## Preventative Maintenance Principles & Guidelines: Week 5

### General Maintenance Guidelines

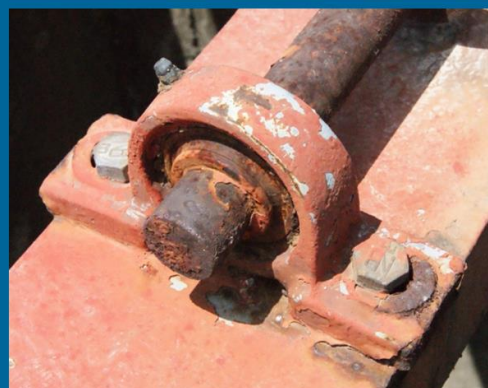
### Bearings

#### Bearings - Monthly

- Clean thoroughly
- Check for excessive vibration, noise & temperature
- Check for sufficient lubrication
- Examine for any mechanical damage or corrosion
- Remove corrosion & paint

#### Bearings – Six Monthly (Depending on usage)

- Examine bearings - if rough replace; alternatively clean & re-grease
- Grease all grease points
